# Arresting building settlement with a supplementary foundation

An office building was undergoing active settlement, with new cracks appearing along its front elevation. Following DCP investigation and remedy assessment, a supplementary foundation comprising 20 steel micropiles was selected to arrest further settlement.

# Chống lún tòa nhà bằng móng phụ

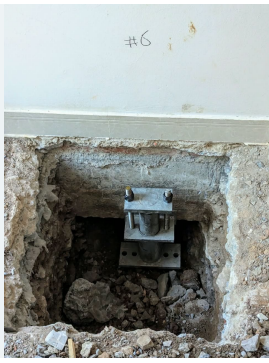
## Site photographs

Selected sequence: building overview; second overview; excavation exposing the existing ground beam; hydraulic micropile installation; completed micropile connection. The backfilling photograph is excluded.

URETEK Vietnam carried out an in-situ Dynamic Cone Penetrometer survey, assessed remedy options and prepared the method statement for a steel-micropile system. Twenty micropiles were installed to the as-built layout. Installation pressure was recorded by depth for every location, with continuing coordination and monitoring by the site engineering representatives.

The project report and handover record confirm delivery of all 20 micropile locations, completion and handover on 18 November 2024, and satisfactory assessments for quality, quantity and schedule.

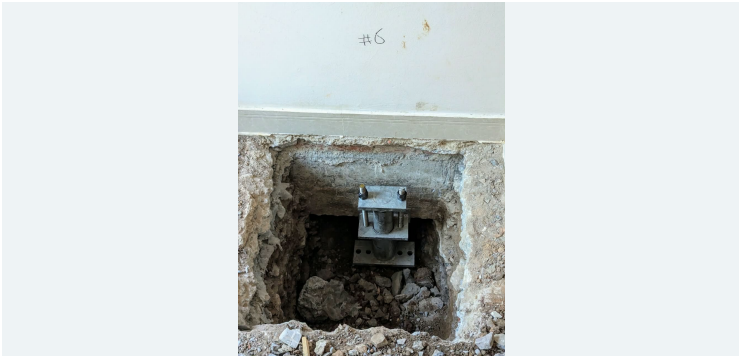
## Ảnh công trường

Trình tự đã chọn: toàn cảnh tòa nhà; góc toàn cảnh thứ hai; đào mở để lộ đà kiềng; ép cọc bằng kích thủy lực; cọc hoàn thiện liên kết với đà kiềng. Không sử dụng ảnh lắp trả.

URETEK Việt Nam thực hiện khảo sát xuyên động DCP tại hiện trường, xem xét các phương án và lập biện pháp thi công cho hệ micropile thép. Hai mươi cọc được lắp đặt theo bản vẽ hoàn công. Áp lực lắp đặt được ghi nhận theo chiều sâu cho từng vị trí, với sự phối hợp và giám sát liên tục của đại diện kỹ thuật tại công trường.

Hồ sơ dự án và biên bản bàn giao ghi nhận đủ 20/20 vị trí micropile; công việc hoàn thành và bàn giao ngày 18/11/2024; chất lượng, khối lượng và tiến độ đều được đánh giá đạt yêu cầu.
